# Popham Building Historical & Structural Report

81 Water Street  
Apalachicola, FL 32320

July 2024

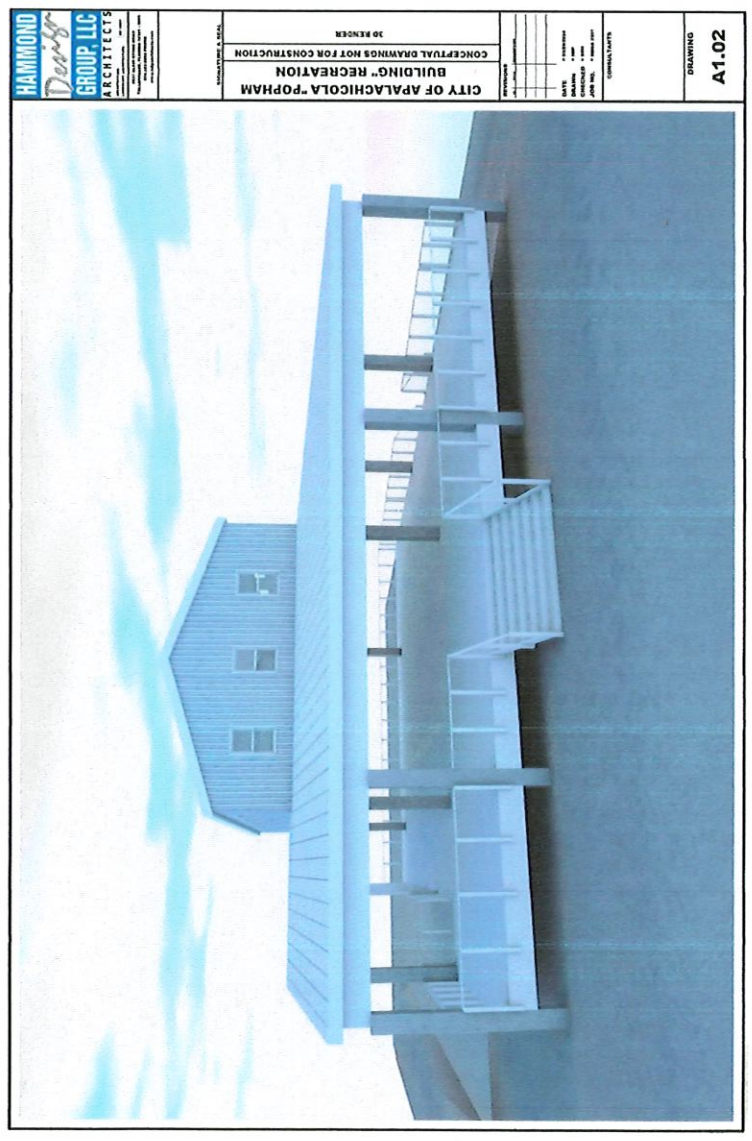
Preliminary concept recreation used for the purposes of costing and comparison to the existing structure.

4. We recommend the construction of a new open air pavilion with a similar footprint that could be utilized for City events and perhaps provide income generation, as location for weddings and private events. We have included a preliminary concept utilized for costing purposes, on page 8 of this executive summary.

Our recommendation is to build an open air pavilion that can serve the community for future years. The costs associated with a new structure compliant with current code is roughly 1/2 the cost of restoration. The new structure should celebrate the rich history of the Popham building and the community. We believe that plaques, photos or elements of the existing building could be incorporated into educational exhibits within the pavilion to further educate the public of the rich waterfront history of the City of Apalachicola.
